INTERNATIONAL CONFERENCE of SCIENTIFIC PAPER  
AFASES 2015  
Brasov, 28-30 May 2015

## THE INFLUENCE OF $Al_2O_3$ DEPOSITED COATING BY PLASMA ELECTROLYTIC OXIDATION TO THE BEHAVIOR OF AN ALUMINUM ALLOY SUBJECTED TO MECHANICAL SHOCK

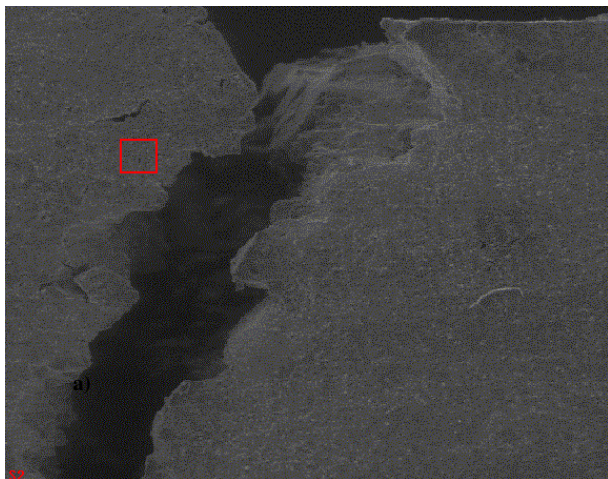
The EDAX analysis presented in fig. 5 showed a good adherence between  $\text{Al}_2\text{O}_3$  coating and aluminum alloy material base. In

this analysis we can observe only chemical elements of the coating.

Fig. 5. The EDAX analyses for the sample with  $\text{Al}_2\text{O}_3$  coating: (a) on the surface with the remained coating, (b) on the exfoliation surface
